## Ground Improvement for Existing Structures

January 9, 2019

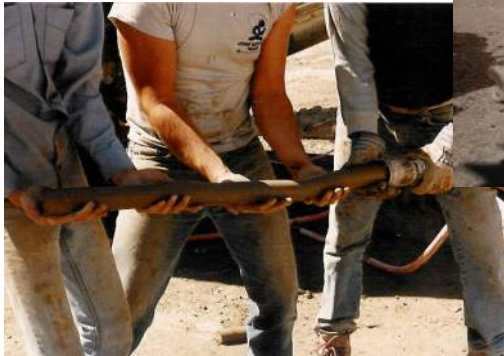
## Ideal Grout Make-Up

- ◆ Pumpable
- ◆ Slump less than 2" for pre-treatment and around 1" for underpinning and piles
- ◆ 10-20% cement by volume

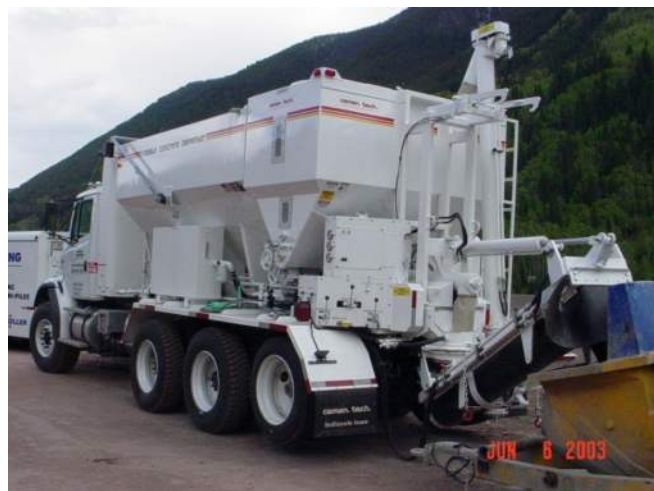
## Grout Batching

### Continuation of grouting:

- ◆ On-site batching will aid control
- ◆ Grout rheology important
- ◆ Pressure, grout quantity, injection rate, and indication of heave are controlling factors
- ◆ Sequencing of plan injection points very important

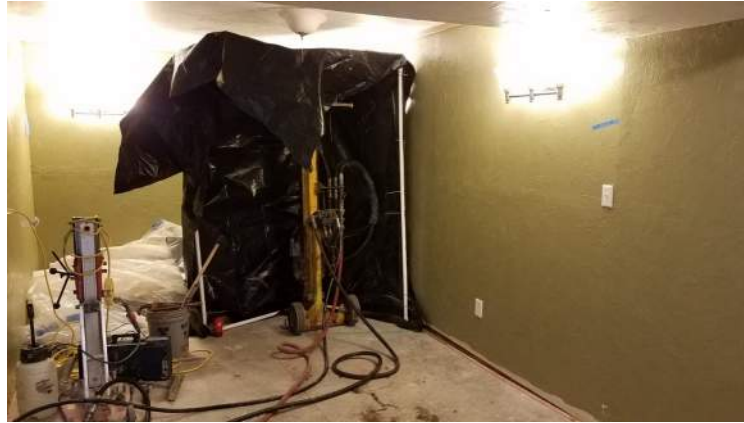
Interior Installation of Grout  
Pipe with Very Small Drill

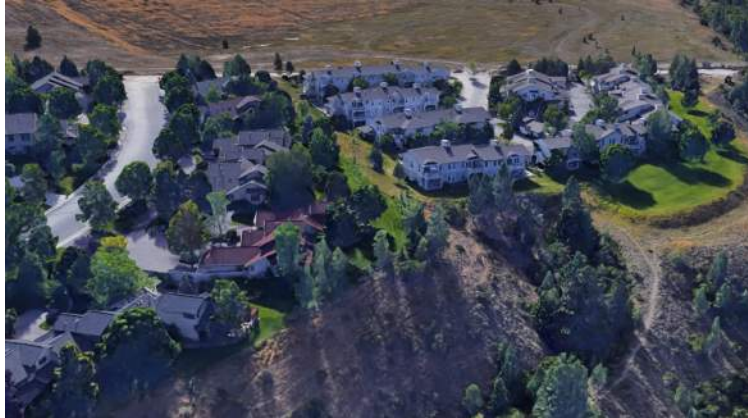
## Case Study: Settling Townhomes

- Hillside in Missoula, MT
- Over historic gully historically used as dump site

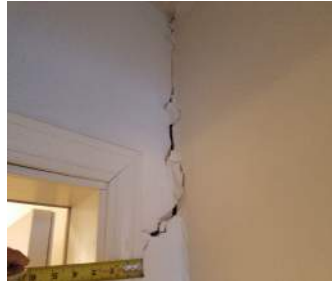
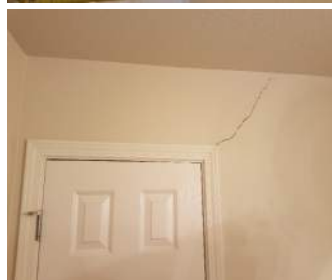
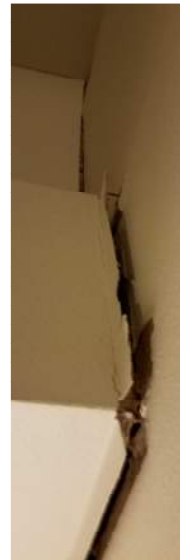
## Examples of Pre Grouting Distress

- Racked doors
- Drywall cracks
- Concrete cracking and settlement
- Cracked windows
- Doors/windows jammed and unserviceable
- High floor slopes
- Negative drainage
- Trip and fire hazards

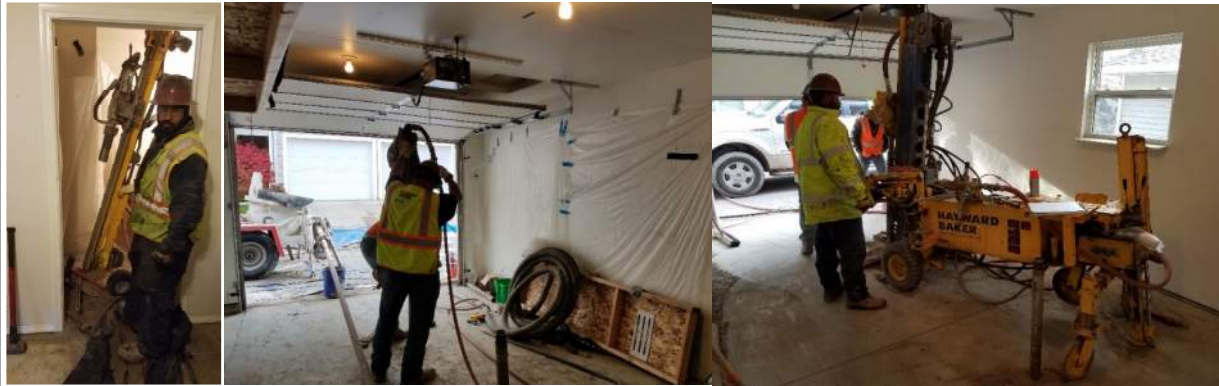
## LMG/Compaction Grouting Process

- Casing advanced to termination depth (typically bottom of gully with pneumatic hammer or drill access drill)

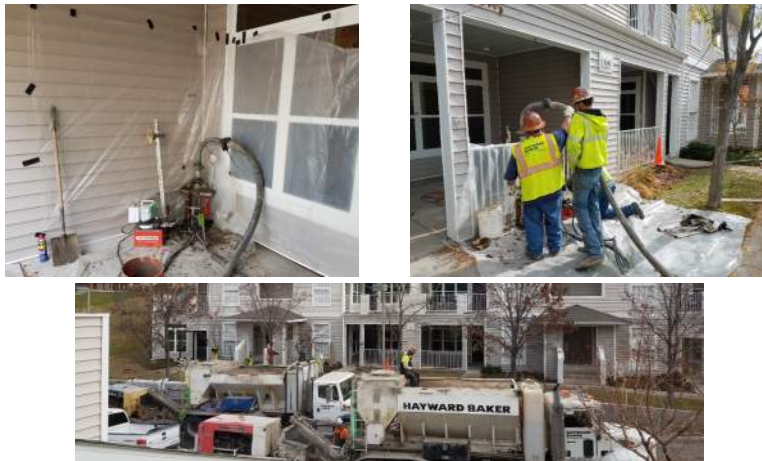
## LMG/Compaction Grouting Process

- LMG grout batched and pumped onsite. Hydraulic rams used to lift casing for each stage.

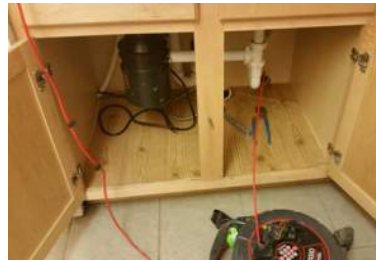
## Monitoring During LMG Grouting

- Monitored slabs, walls, asphalt and retaining walls for vertical and lateral movement
- Employed dial gauges and laser targets
- Monitored plumbing for signs of deflection with camera

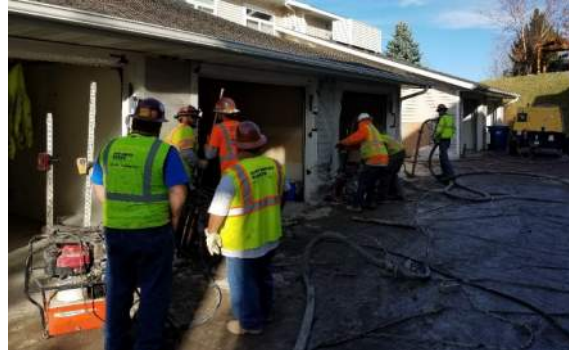
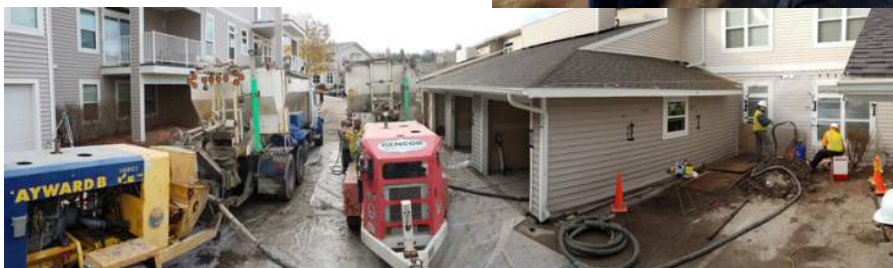
## Lifting

- Lifting completed using two crews pumping simultaneously on 4 to 6 holes each to achieve broad distributed lift.

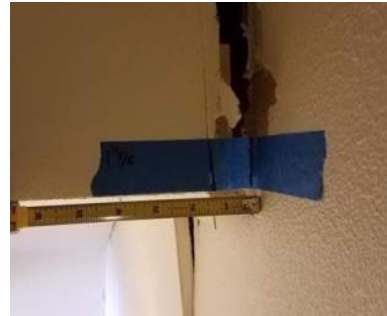
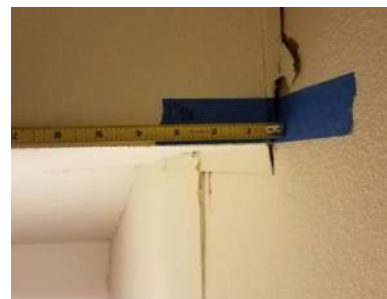
## Results of Lifting

- Lifting process closed many structural cracks
- Reduced cost of cosmetic repairs
- Improved racked doors
- Reset stuck windows
- Reduced floor slopes

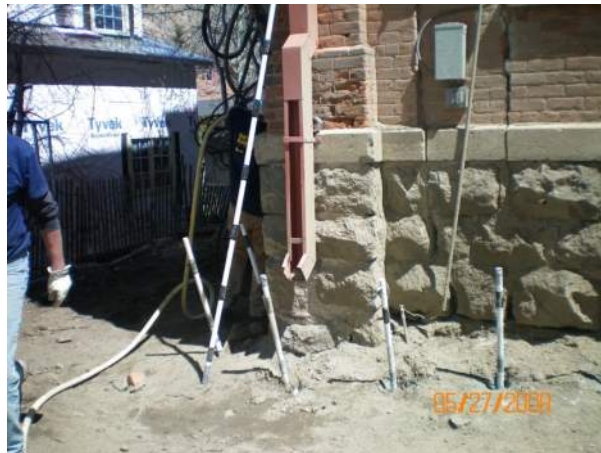
## Chemical (Permeation) Grouting

**Structural Chemical Grouting** is the permeation of non cohesive soils with solution grouts to produce weak sandstone like masses to carry loads or increase stand-up time.

**Water Control Chemical Grouting** is the permeation of sands with fluid grouts to completely fill voids to control water flow.

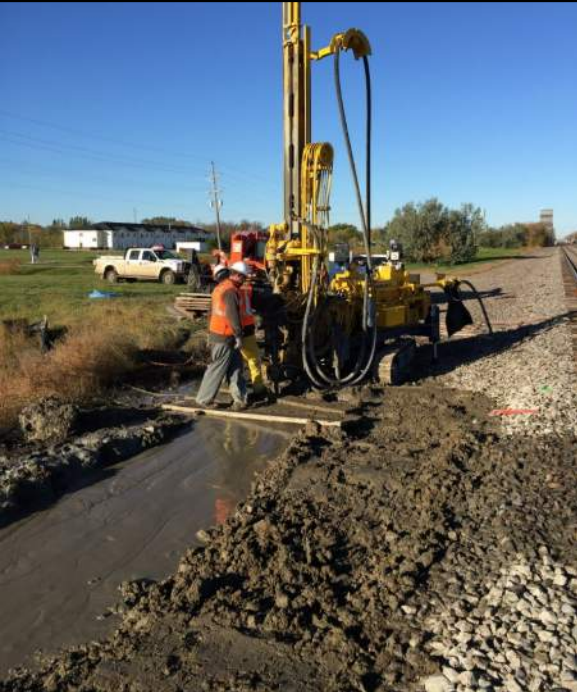
- ◆ Installation of the Test Section
- ◆ Verified 4' diameter columns

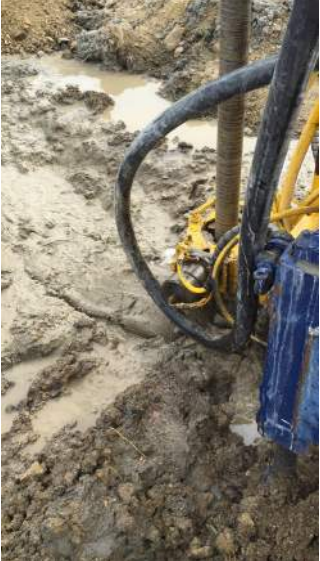
### Case Study: Fargo, ND - Frost Heave Mitigation

- ◆ Double Main and siding had 3 jack and bored culverts
- ◆ Culverts allowed up to 12" of frost heave
- ◆ Jet Grouting to limit frost heave

- Three week project
- Frost heave mitigated
- Slow orders cancelled

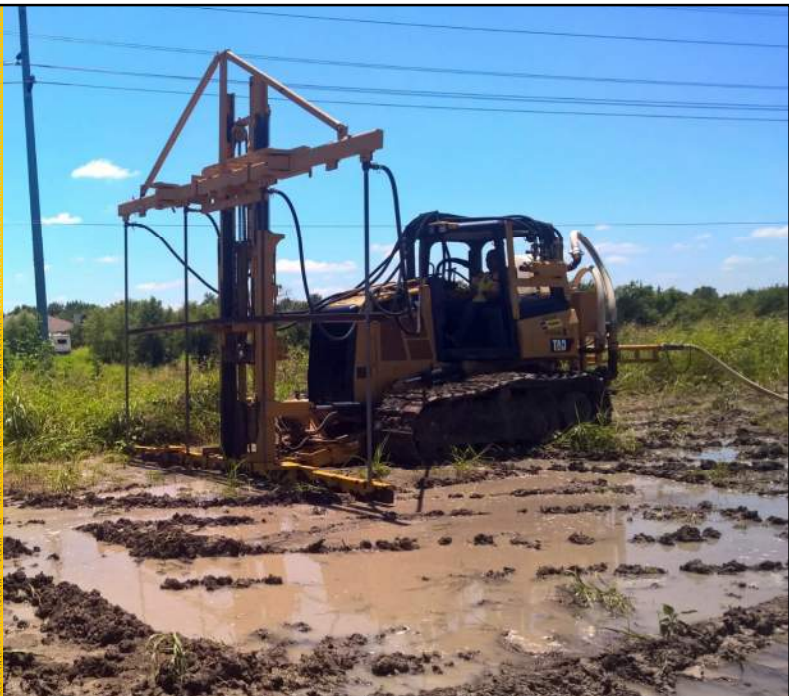
## Injection Systems

Single and multi-point push systems which hydraulically force injection probes into the soil mass.

Fluids or slurries are then pumped through the system in order to pre-swell, modify or improve the strength of the soil mass.

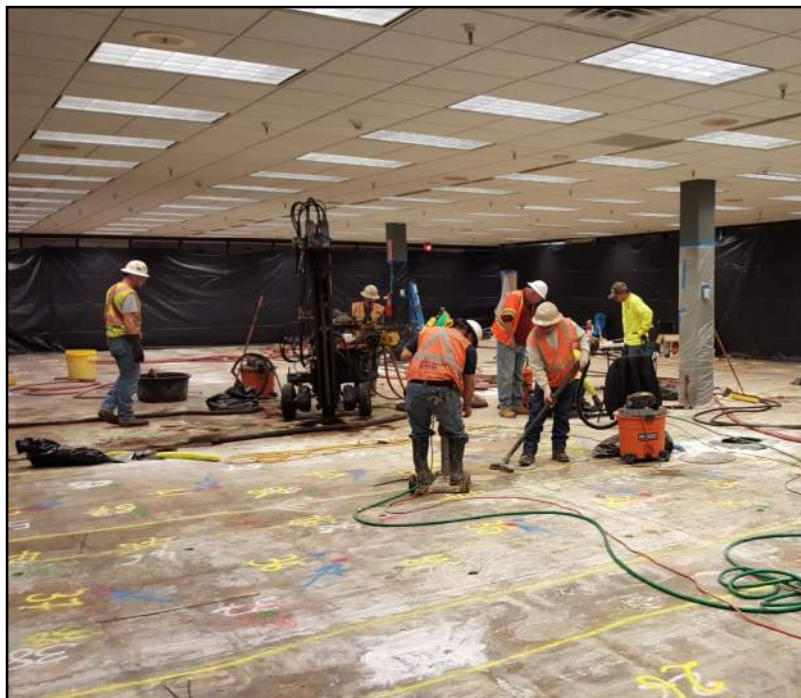
# Types of Injection Equipment

## Outdoor

Multiple rod units, up to 5 rods

## Indoor

Single rod units for work in low headroom conditions  
Or multiple rod units in warehouse

## Deep Injection Units

Injection depth up to 30' deep

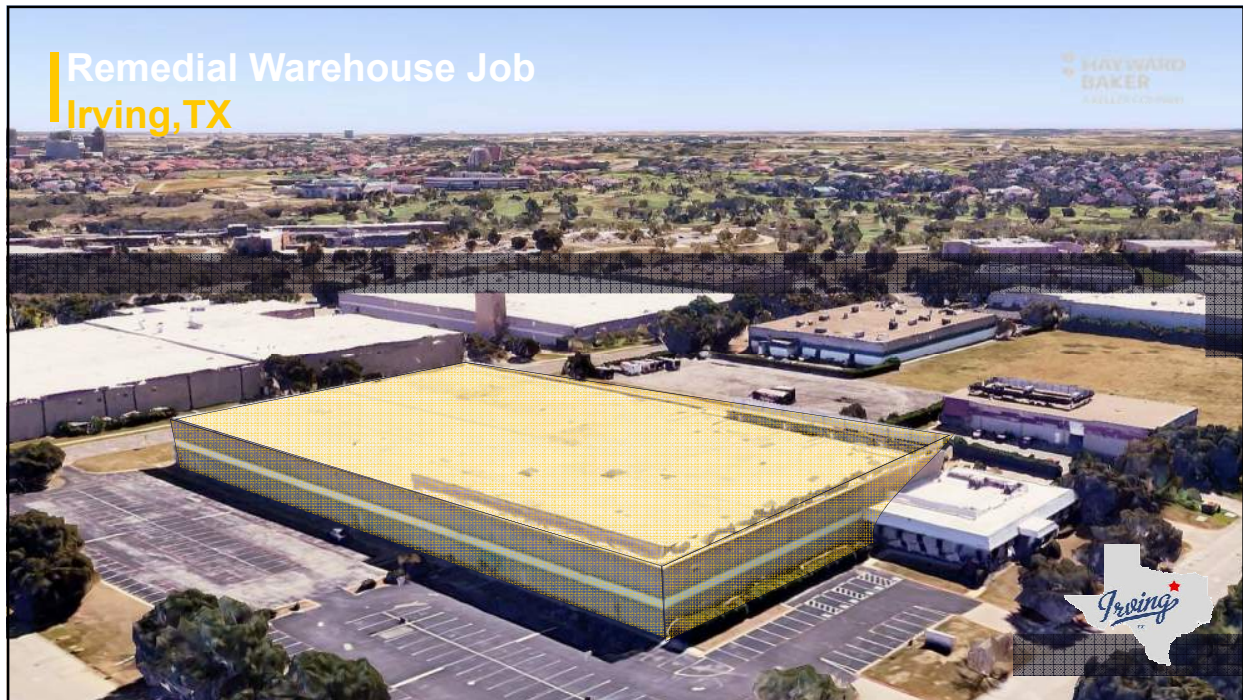
## Remedial Warehouse Job Irving, TX

### Problem:

The slab in the warehouse of the building experienced heave due to expansive soils located beneath the structure.

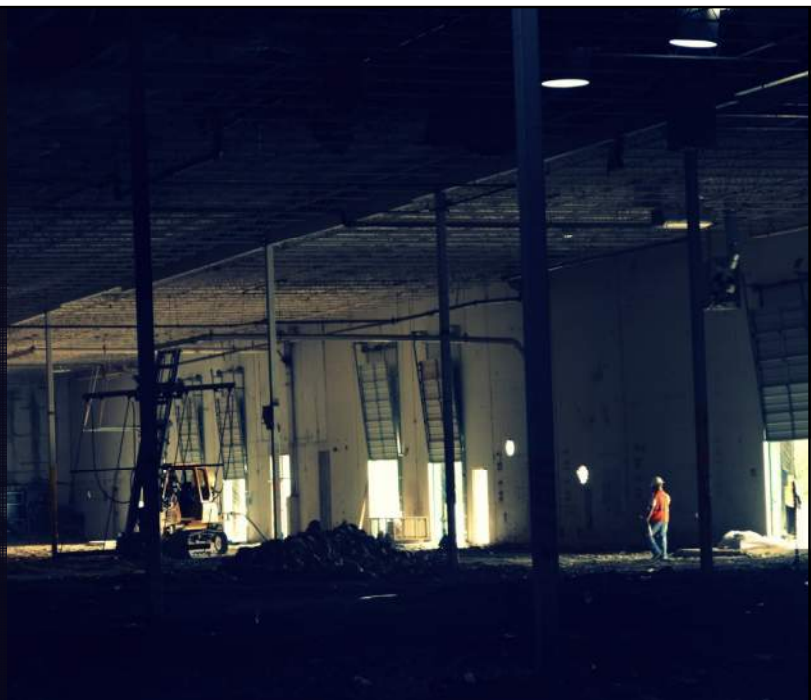
## Injection Area.

- The floor in this area was removed.
- A combination of chemical soil injection and water injection was used to limit the future movement of the soils under the floor slab.

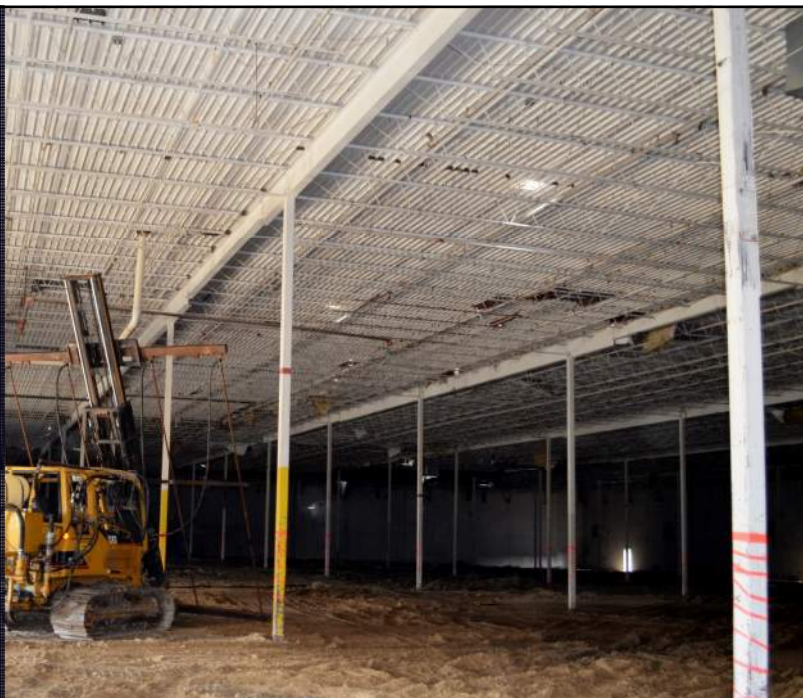
## Injection Plan.

The **potassium** was injected in a five (5') wide strip around the perimeter of the inside of the warehouse and in a ten by ten (10' X 10') area at each column location.

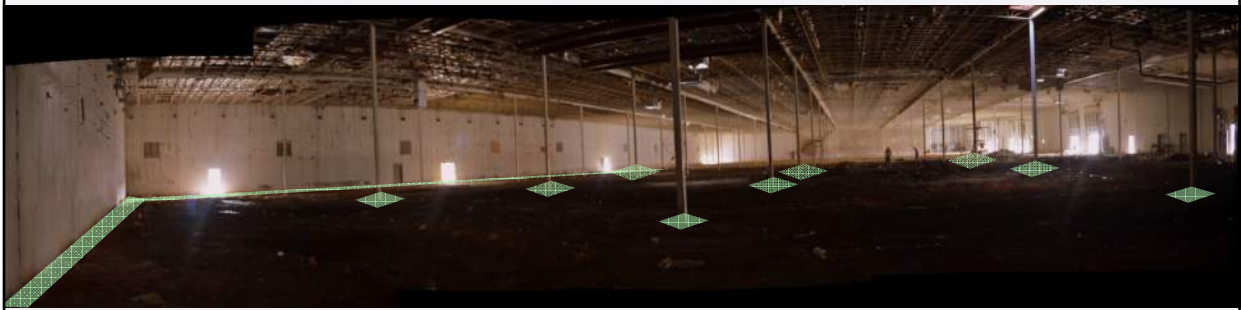
**Chemically Injected Areas (15' Below Grade)**

## Remedial Warehouse Job Irving, TX

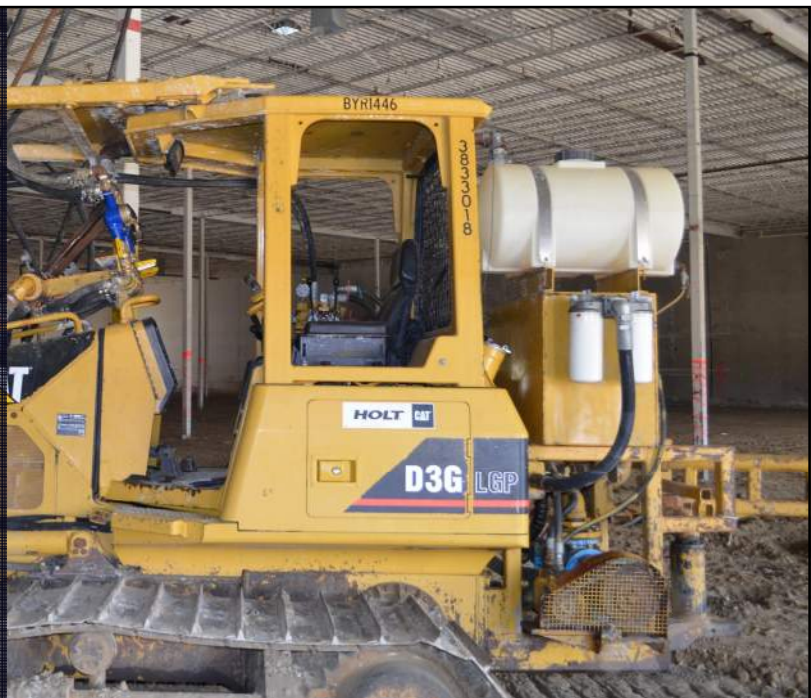
## Quality Assurance

- A daily site progress report was completed.
- Includes area treated each day along with the amounts of all material injected into that area.

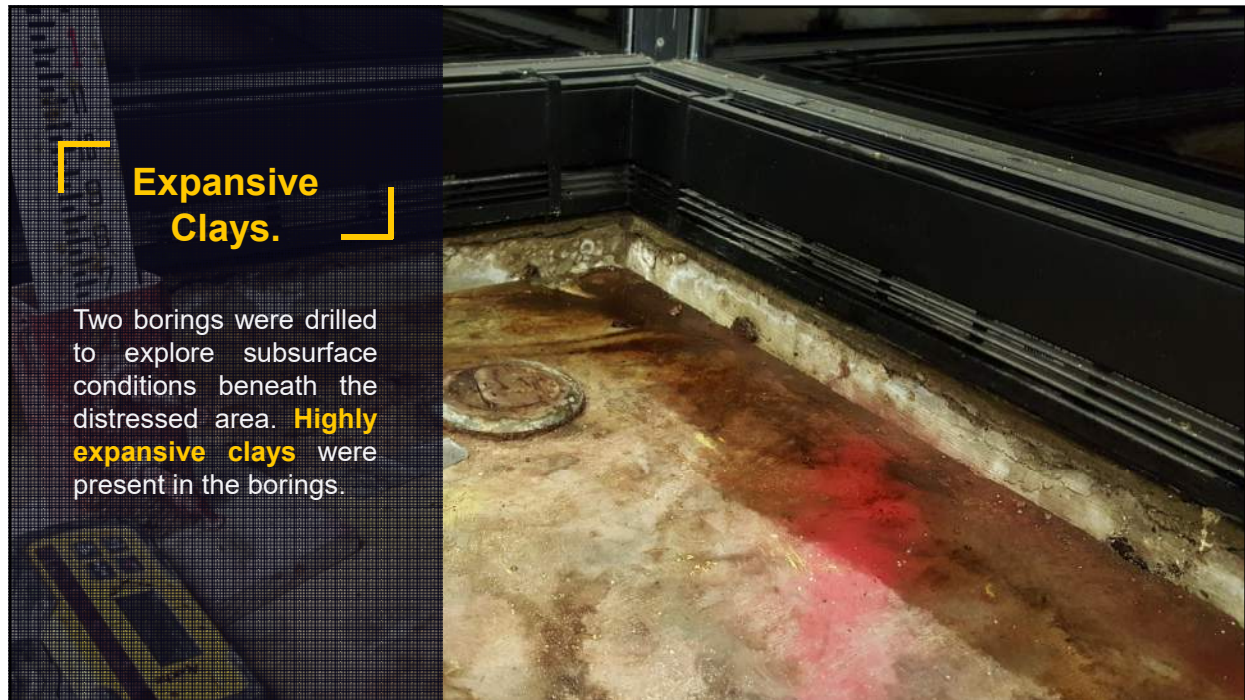
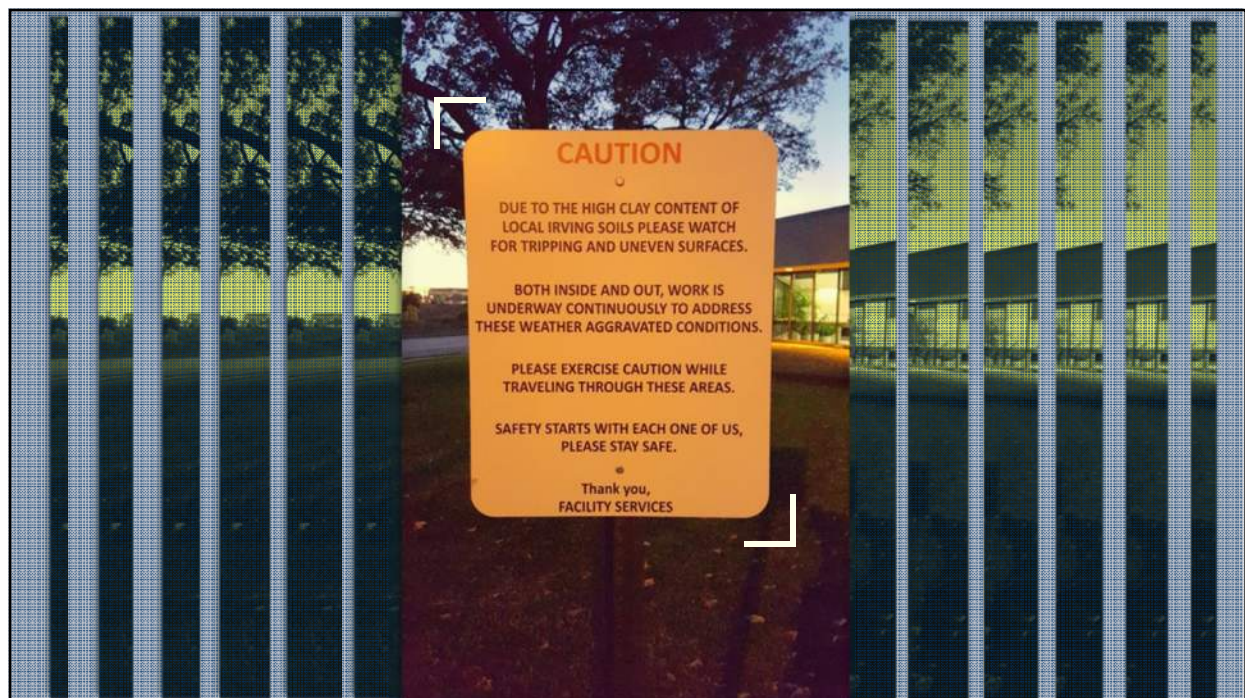
## Remedial Job Irving, TX

### Problem:

The American Honda training center in Irving Texas experienced significant distress in floor slab and flatwork. The settlement of the floor slab was observed on the south side of the building. The brick paver area settled. Portions of the Honda distribution center, training center and warehouse were settling due to drying of underlying expansive soils.

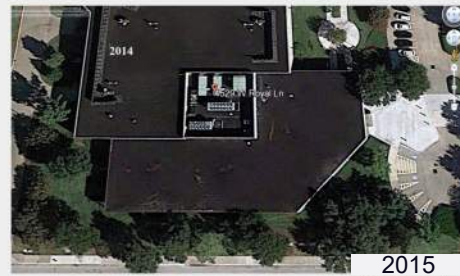
## Causes of Distress.

High hand penetrometer and **high swell** potentials were observed in the borings. This indicates that the soil is **dry** and experienced **shrinkage** in the past. This soil shrinkage is considered to be caused by moisture losses due to the presence of **large trees** near the building.

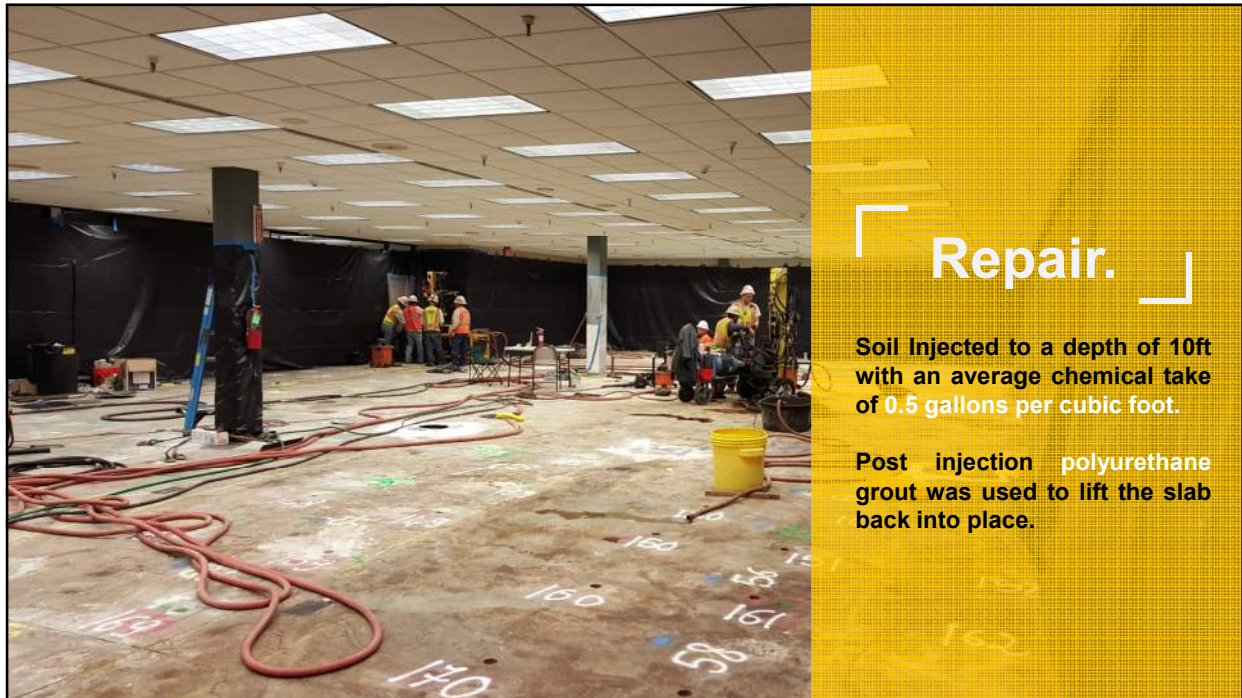
## Options.

Construction of a structural slab over a void space.  
The removal of trees or the installation of root barriers and a new-slab-on-grade after subgrade moisture levels are stabilized.  
Coring the slab and injecting potassium chloride.
